**BUILDING CONDITION ASSESSMENT REPORT**  
**CITY OF STRATFORD COOPER SITE**  
**350 DOWNIE STREET, STRATFORD, ONTARIO**

Issued Date: June 25, 2012

RJC Project # TOR103282.0003

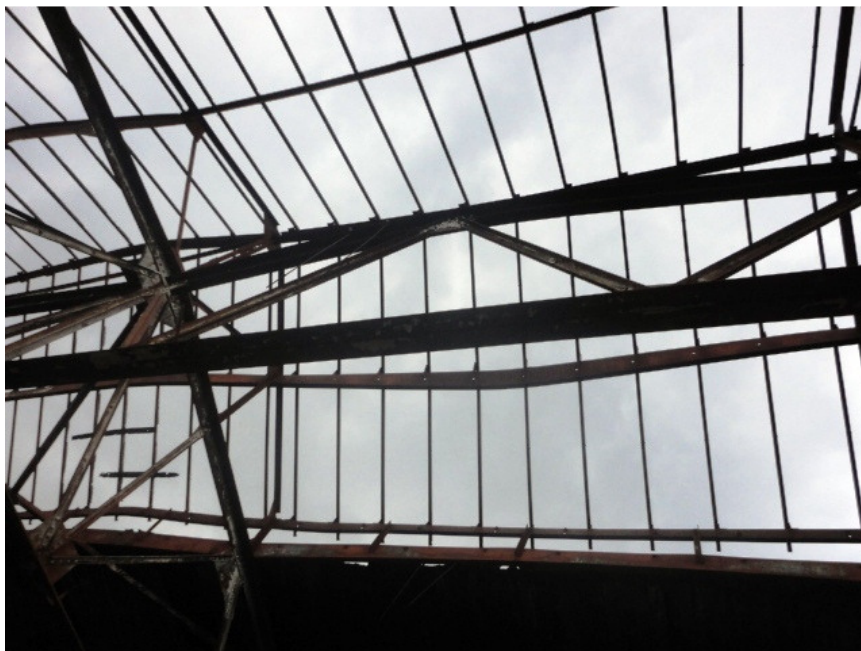
Photo #15: Typical warped purlins in fire damaged region

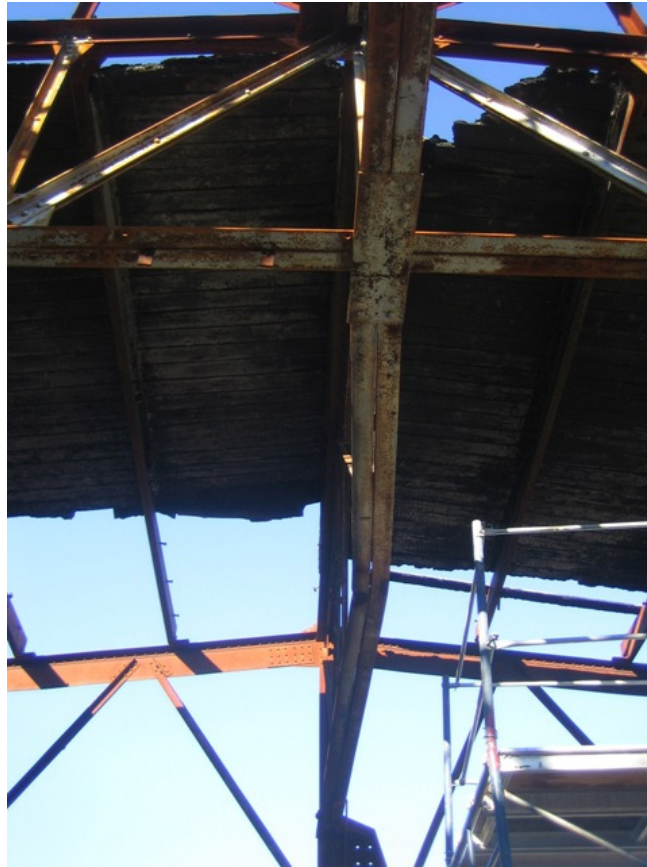
Photo #16: Typical warped tie-truss in fire damaged region

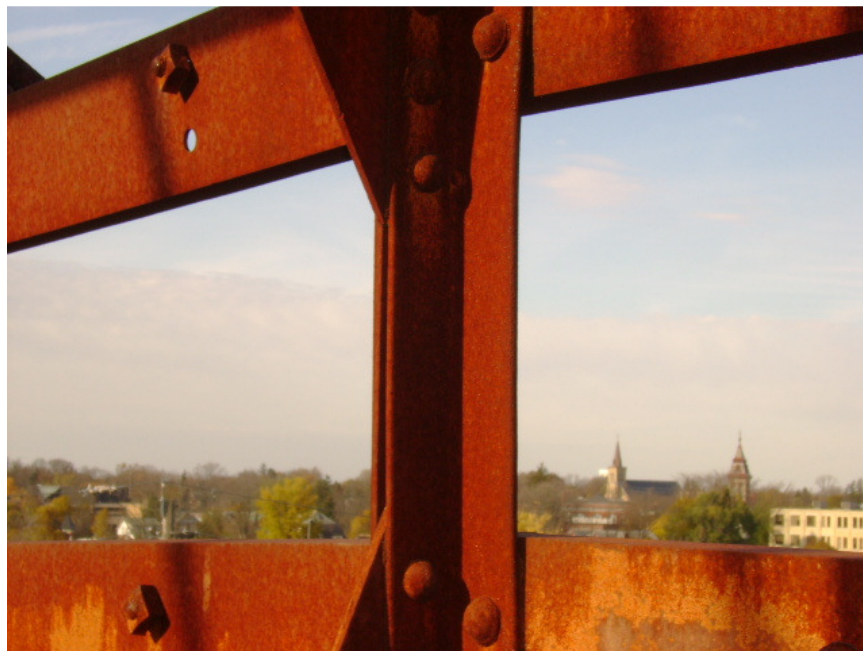
With the west end of the original building being exposed due a fire, varying degrees of corrosion and damage was observed in the roof structure. In the fire damaged areas (between gridlines 1 and 12), more extensive surface corrosion was observed on the purlins and trusses, particularly in the apex zone of the roof (*refer to Photo #14 in Appendix A*). Also observed in that area were warped purlins (*refer to Photo #15 in Appendix A*), warped members of the centre tie-trusses (secondary trusses perpendicular to main roof trusses) (*refer to Photo #16 in Appendix A*), as well as typical warping of the truss members on the vertical faces of the apex in the low bay (*refer to Photo #17 in Appendix A*).

Photo #17: Typical warped apex vertical member in fire damaged region

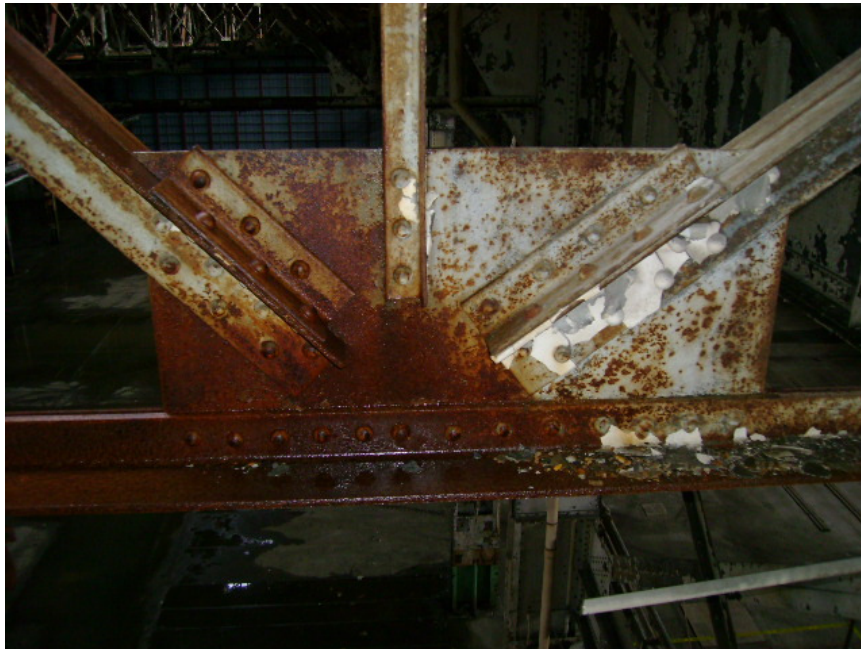
Photo #18: Typical corrosion along bottom chord of roof truss

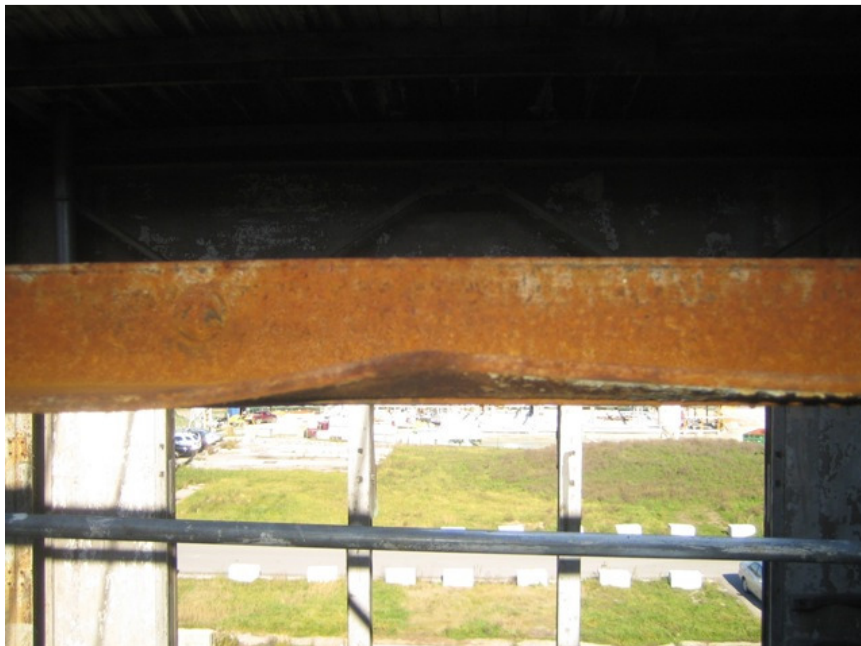
In isolated locations, dented members were identified, likely the result of some form of impact during original construction or operation of the facility (*refer to Photo #19 in Appendix A*). Several locations were identified with more significant rivet corrosion, generally in areas of heavier corrosion of the truss members (*refer to Photo #20 in Appendix A*). There were also only a couple of locations observed where truss members were bowed out of plane.

Photo #19: Typical dent/kink in truss member

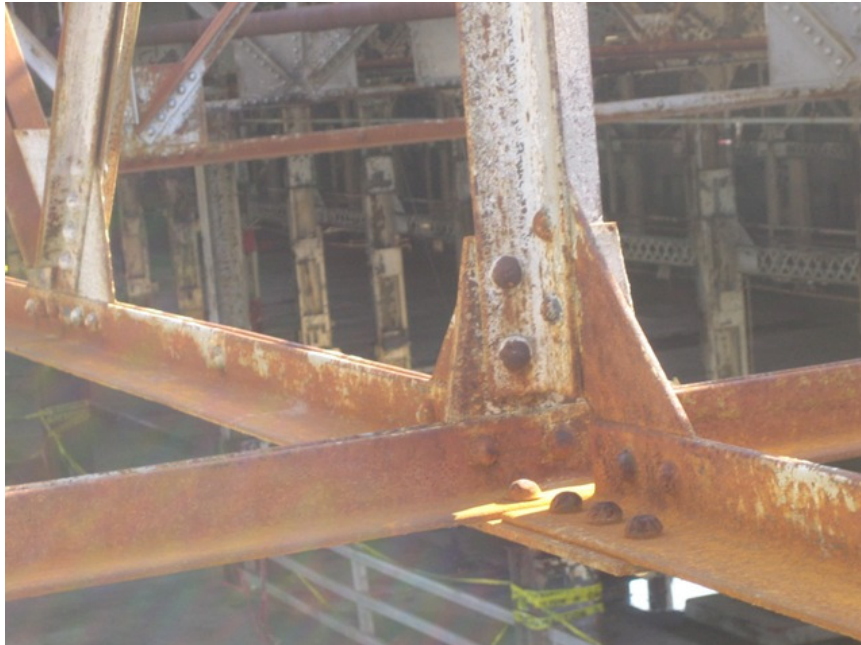
Photo #20: Typical rivet corrosion

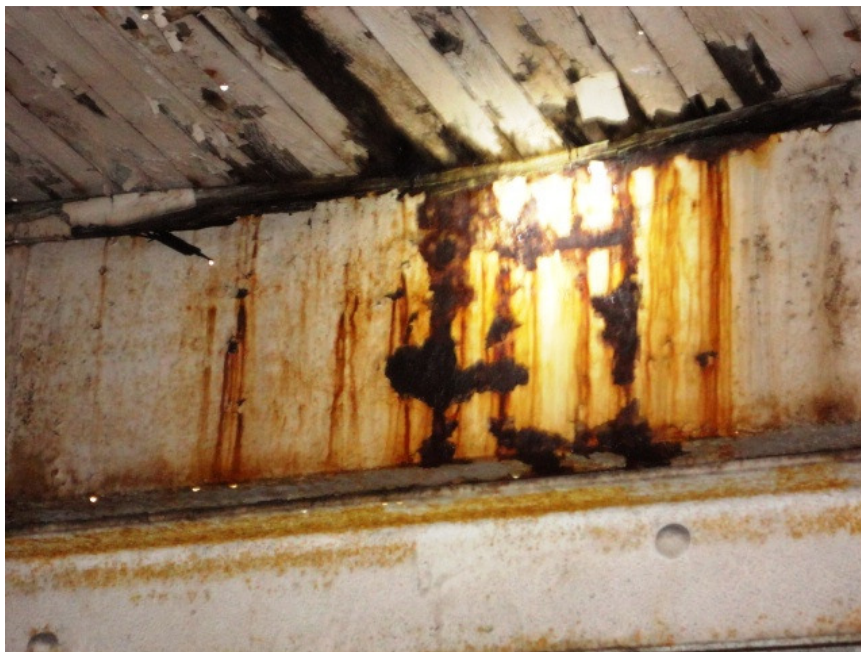
Photo #21: Typical roof leak causing corrosion on top flange of girder in Addition

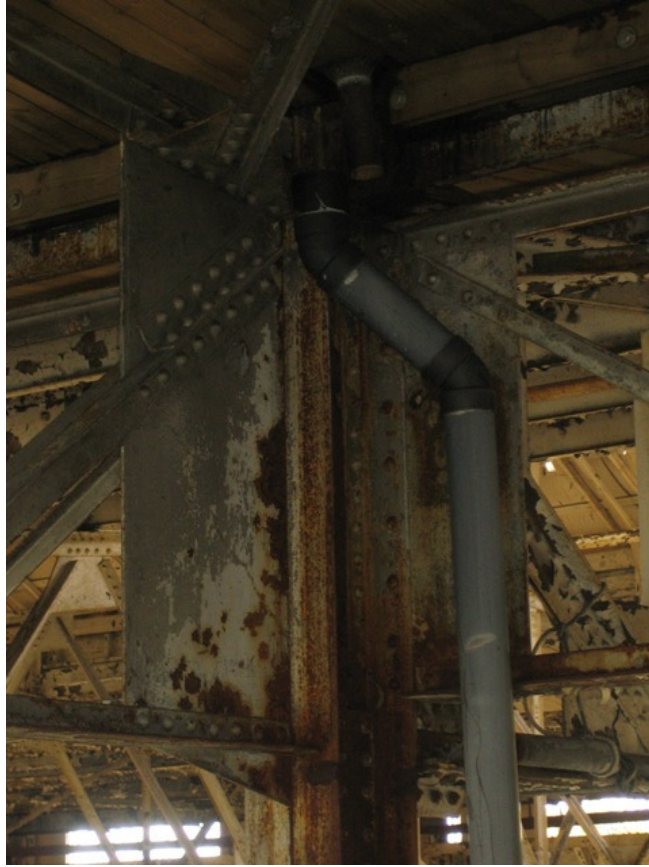
Photo #22: Typical storm water leader and corrosion at top of column

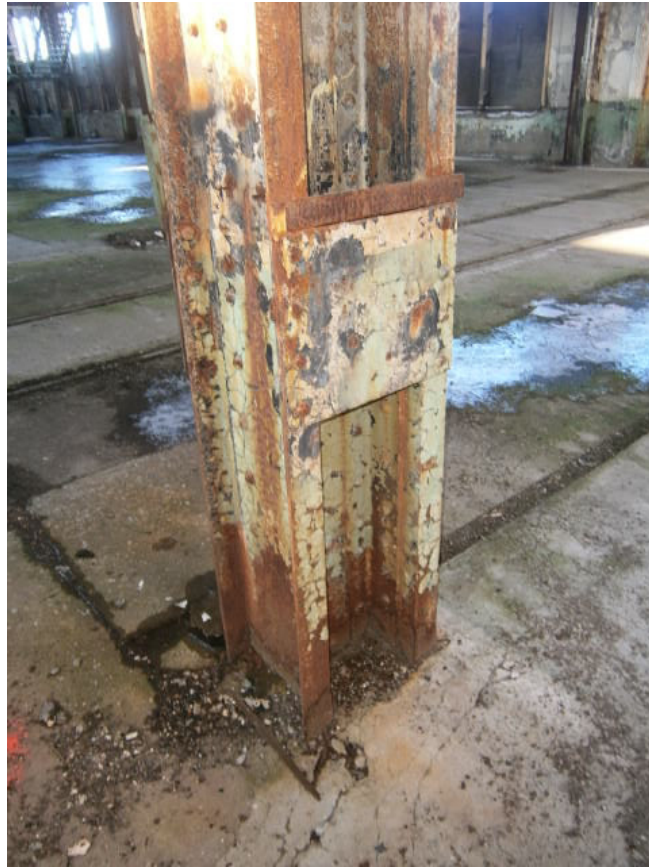
moisture to pour down the columns and through the mezzanine slab to the ground level. This exposure to moisture near the bases of the columns contributed to more rapid deterioration and corrosion of the columns at their bases, where heavier corrosion and section loss was observed (*refer to Photo #23 in Appendix A*).

Photo #23: Typical corrosion at column base

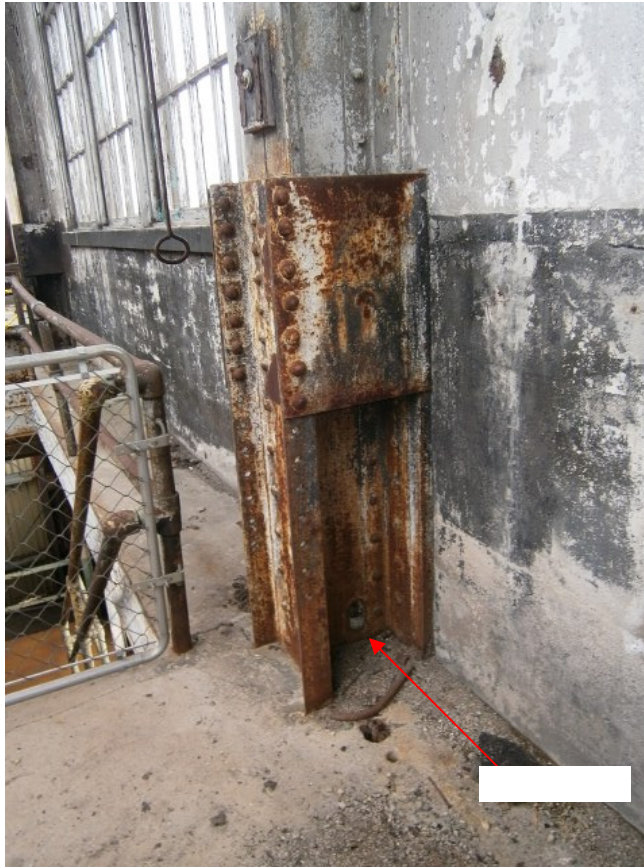
Aside from the typical corrosion at the bases of the columns in the mezzanine bay, some areas were observed with holes burned through the webs of the columns along gridline Fs (*refer to Photo #24 in Appendix A*) and areas with missing rivets along gridline Ds (*refer to Photo #25 in Appendix A*).

Photo #24: Burned hole through column web

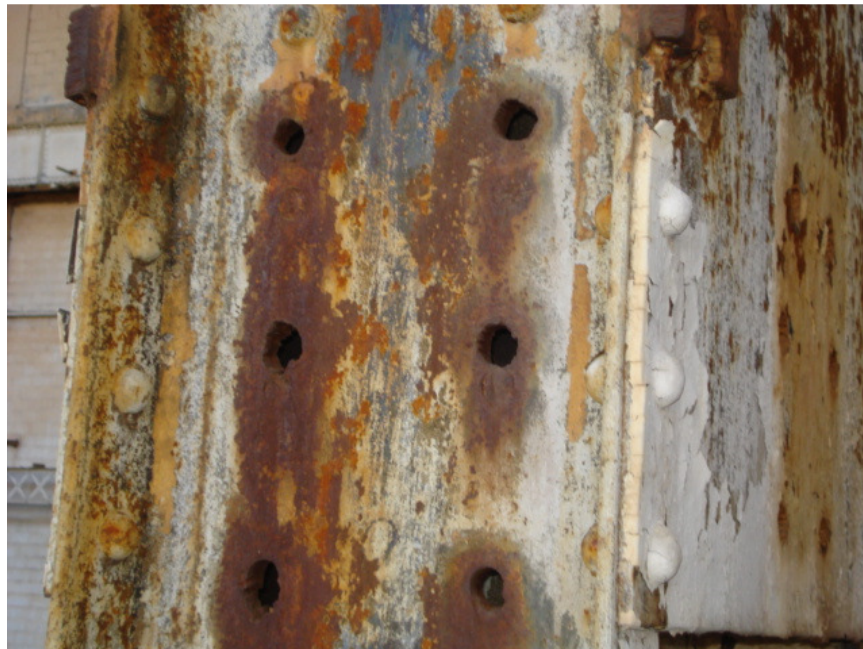
Photo #25: Typical missing rivets on column along gridline Ds

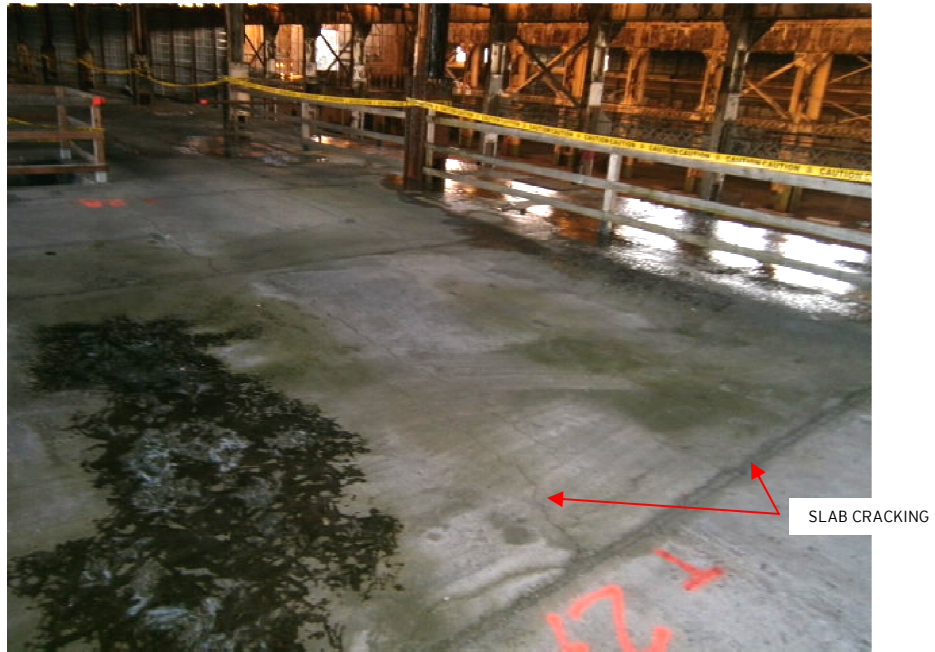
Photo #26: Typical mezzanine slab cracking

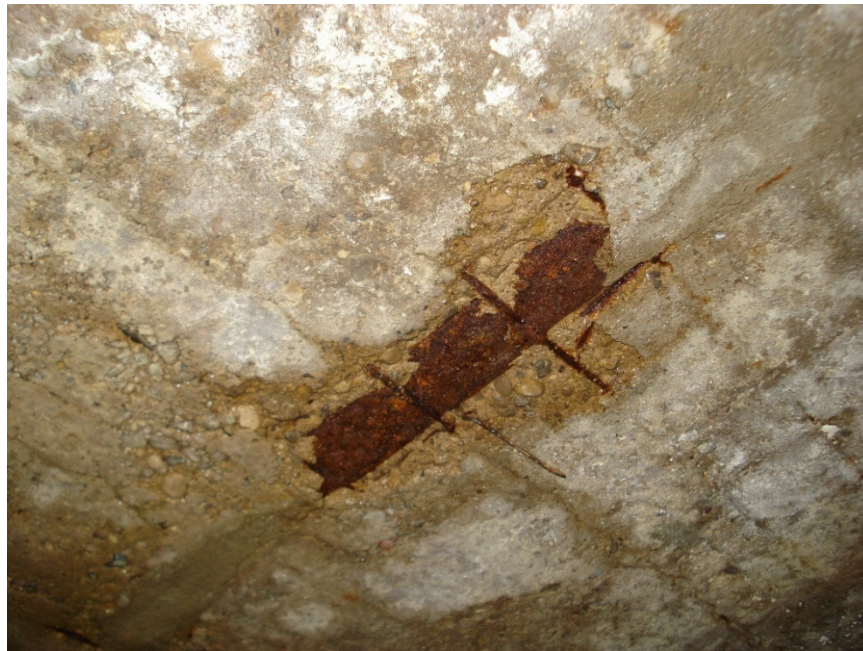
The soffit of the slab had more extensive and obvious signs of deterioration, with several areas of exposed wire-mesh reinforcing either due to minimal concrete cover or spalled concrete (*refer to Photo #27 in Appendix A*). Flaking paint was observed throughout the soffit and rust stains were generally more prevalent near the exterior wall, the cantilevered edge, and around openings and penetrations through the slab (*refer to Photo #28 in Appendix A*). It should be noted that the type of reinforcement used for the slab could not be confirmed by visual inspection but appeared to be simply a wire-mesh laid in near the middle-bottom of the slab.

Photo #27: Mezzanine slab soffit delamination and exposed reinforcing steel

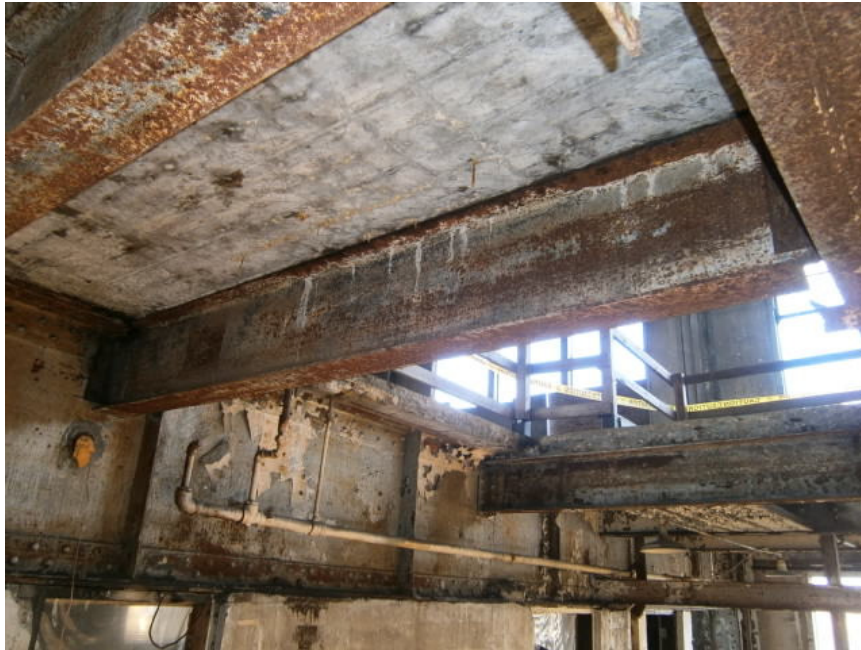
Photo #28: Typical corroded steel and slab soffit deterioration near slab opening

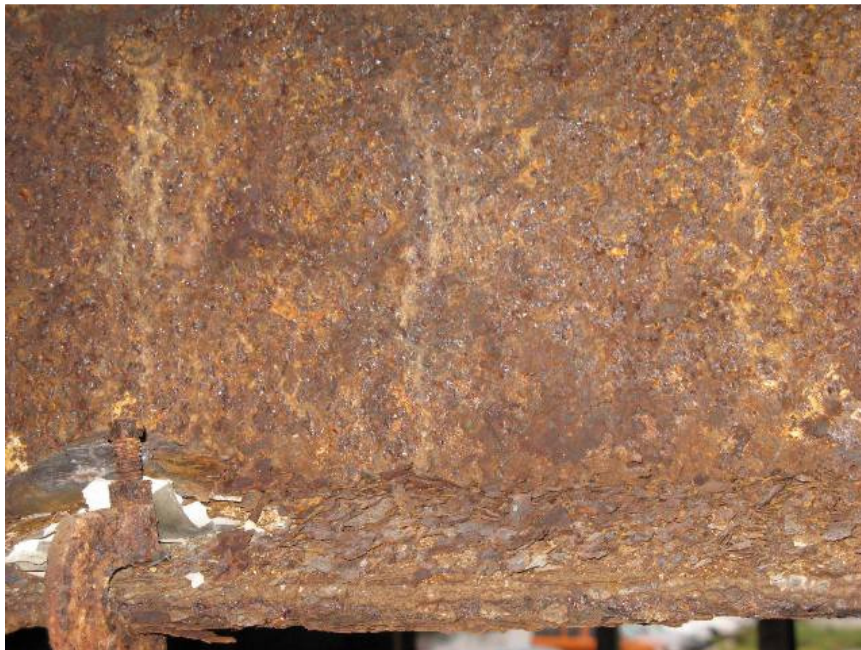
Photo #29: Heavily corroded bottom flange of steel girder below mezzanine slab

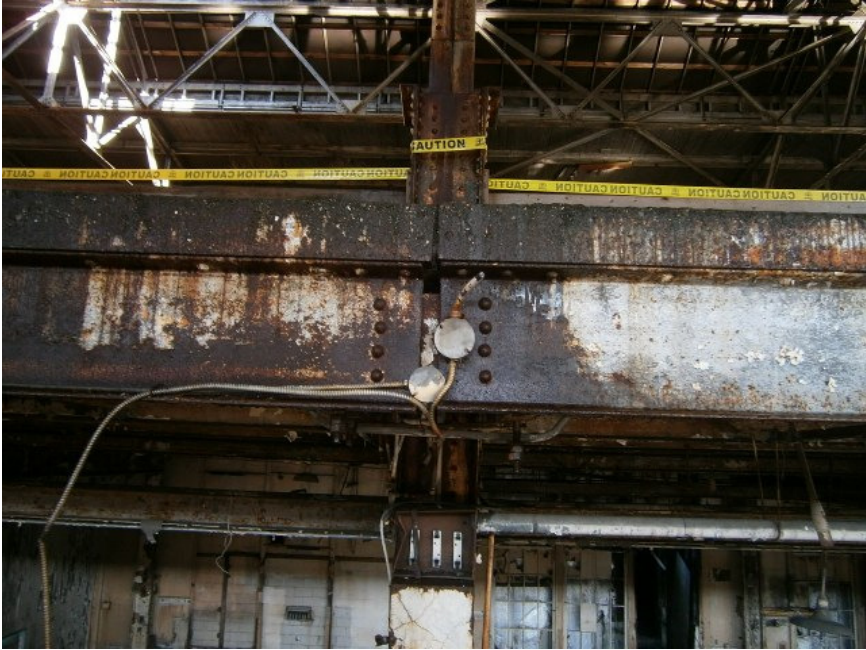
The mezzanine floor framing was comprised of steel girders and beams and was generally found to have flaking paint and minor surface corrosion throughout. Areas of heavier corrosion and some section loss were also typically observed near the exterior wall at Fs and near the cantilever beyond Es. Steel members framing openings were observed to experience heavier corrosion and the corrosion was most prevalent on the top and bottom flanges of the beams and girders as well as at the beam connections to the girders (*refer to Photo #29 in Appendix A*). The cantilevered slab edge channel was observed to be heavily corroded for the length of the mezzanine due to water essentially cascading over the edge of the mezzanine slab during rainfalls, with higher degrees of corrosion observed near the column gridlines (*refer to Photo #30 in Appendix A*).

Photo #30: Typical corrosion of steel at mezzanine slab edge

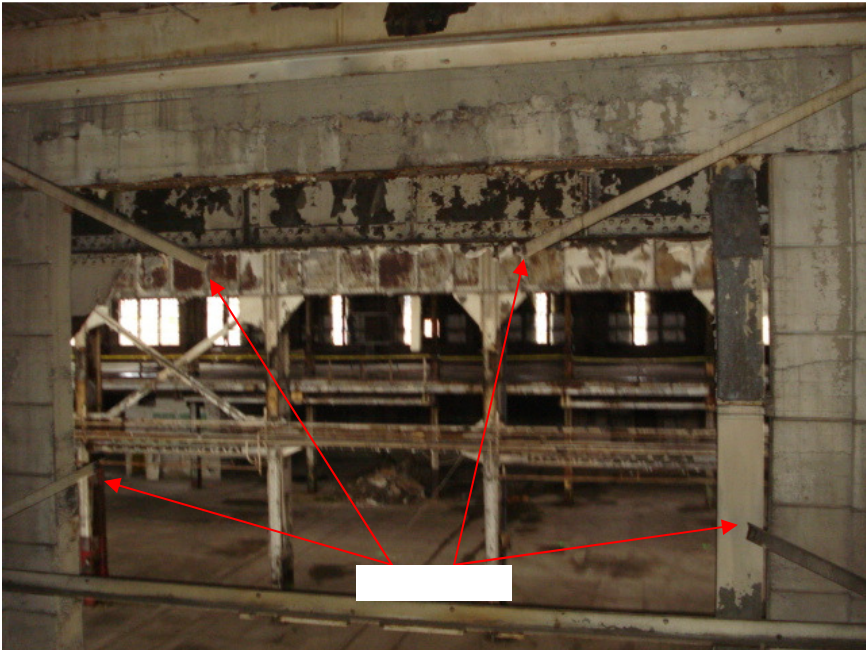
In the addition, no major issues were observed with the horizontal bracing with the exception of 2 bays along gridline Cs near the east end of the building where members of the vertical cross-bracing were torched out (*refer to Photo #31 in Appendix A*).

Photo #31: Vertical cross-bracing cut-out in addition

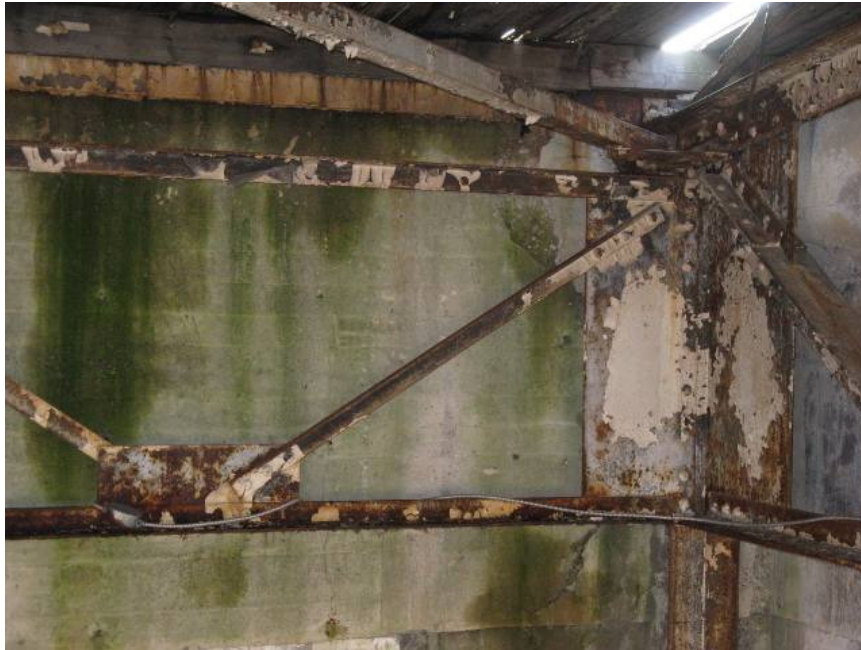
In the original building, the tying trusses framing into the main roof trusses were typically warped out of plane in the fire-damaged area, likely the result of heat induced stress-relief due to the lack of an expansion joint in the original building (*refer to Photo #16 in Appendix A*). The lateral systems in the fire-damaged area also experienced surface corrosion as a result of their exposure, with some heavier corrosion and section loss observed in the upper tying trusses along gridline Cs (*refer to Photo #32 in Appendix A*).

Photo #32: Corrosion at tying truss near grid 'Cs-1'

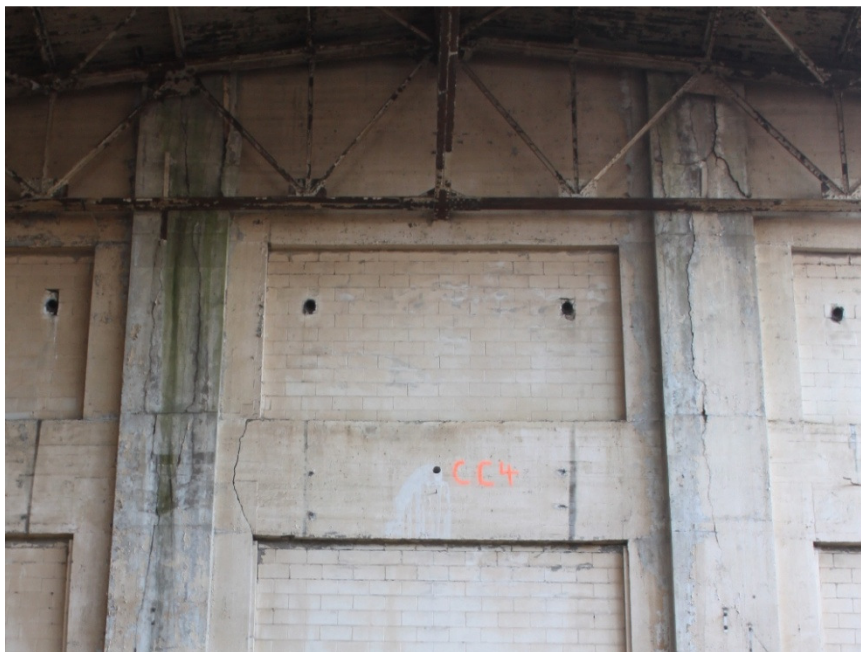
the walls. Severe deterioration, cracking, and spalling concrete was observed at the west end of the building (*refer to Photo #33 in Appendix A*). General exterior wall deterioration observed throughout the building included the following:

- Horizontal cracking and sill delamination of horizontal bands for full length;
- Vertical cracking through vertical bands for full length;
- Cracking (vertical, horizontal, and/or diagonal) propagating from corners of window openings;
- Spalling and delamination of concrete corners at top of foundation wall band.

Photo #33: Exterior concrete wall deterioration

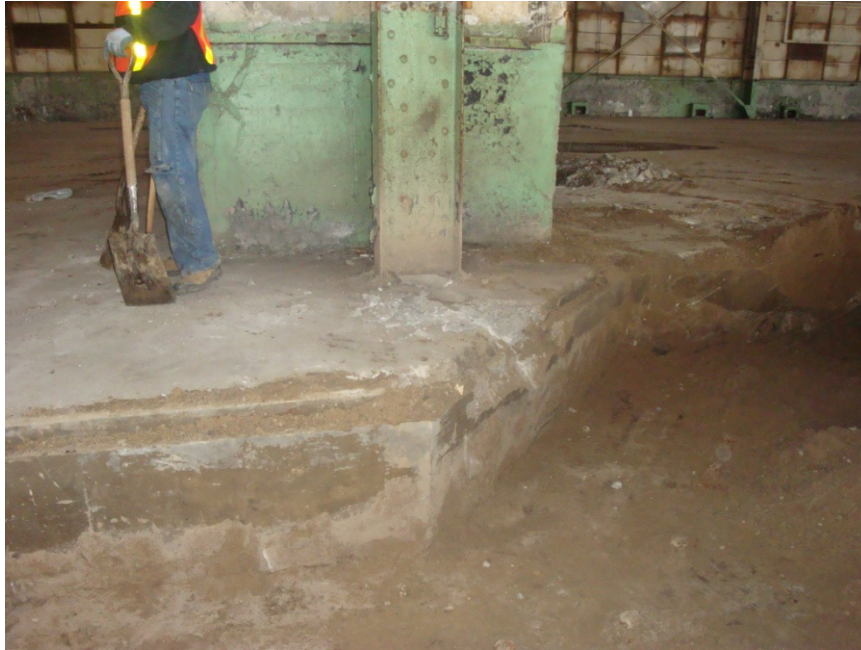
Photo #38: Test Pit #4 - Concrete Pit interference

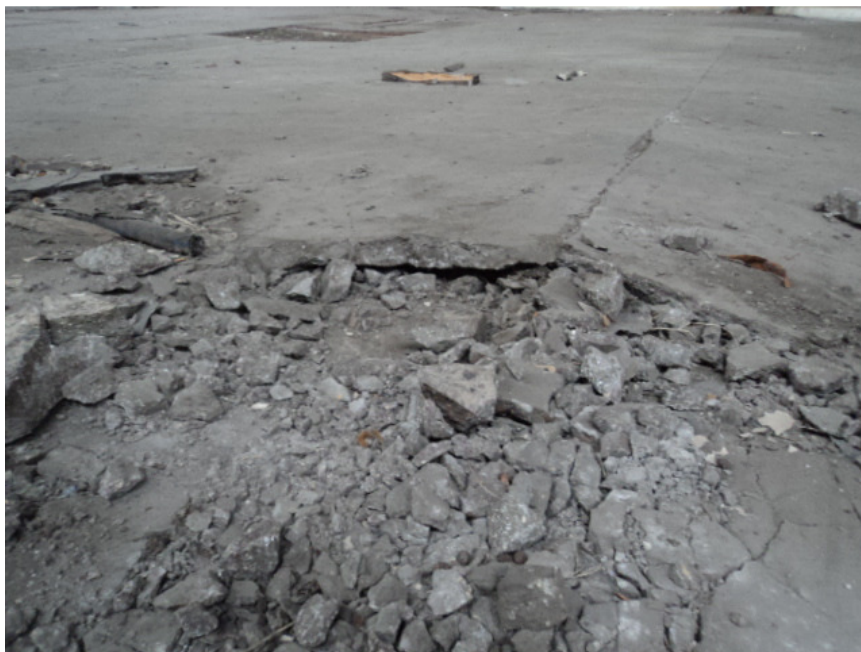
Photo #43: Slab-on-grade area of deterioration/damage

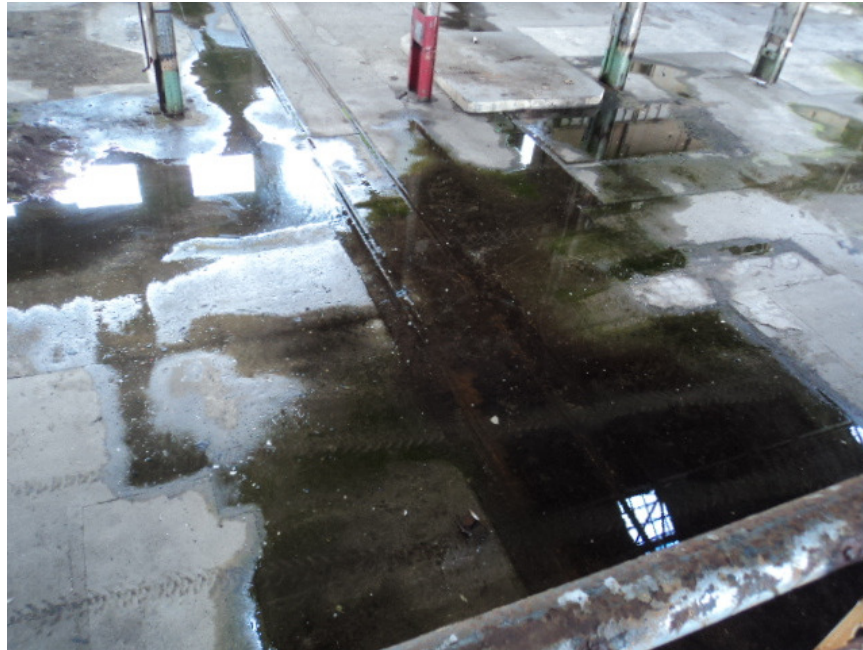
Photo #44: Slab-on-grade area of differential settlement

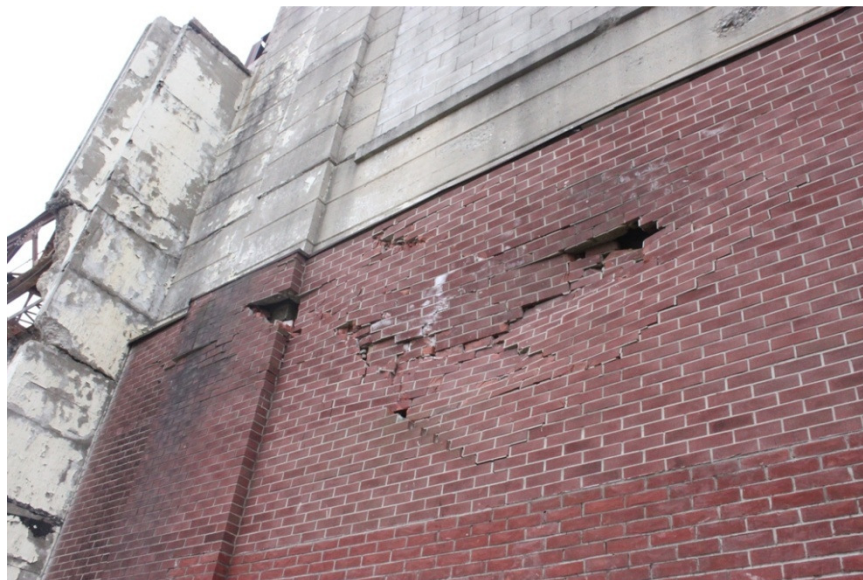
Photo #45: Impact damage and deterioration of exterior brick veneer

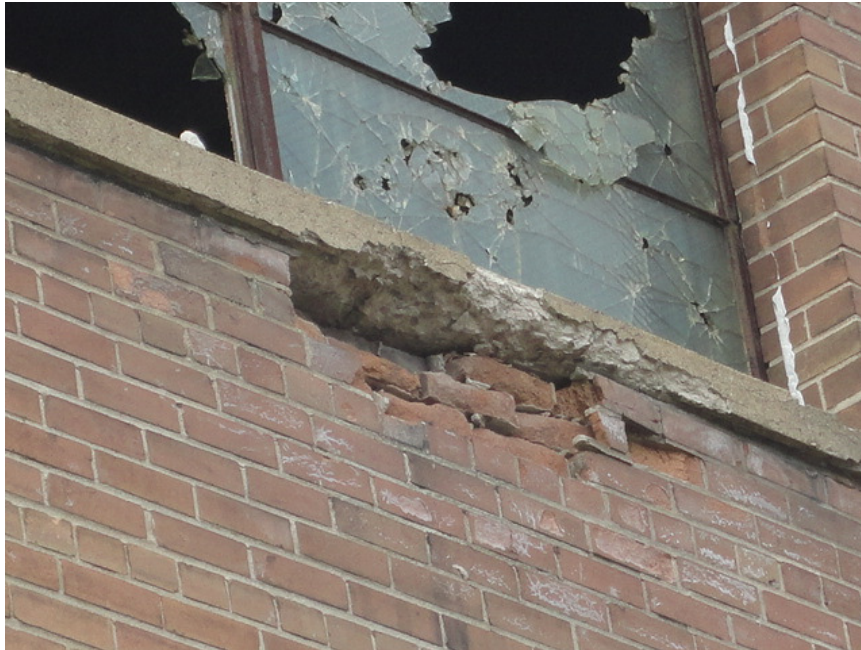
Photo #46: Typical deterioration of concrete sill and masonry below

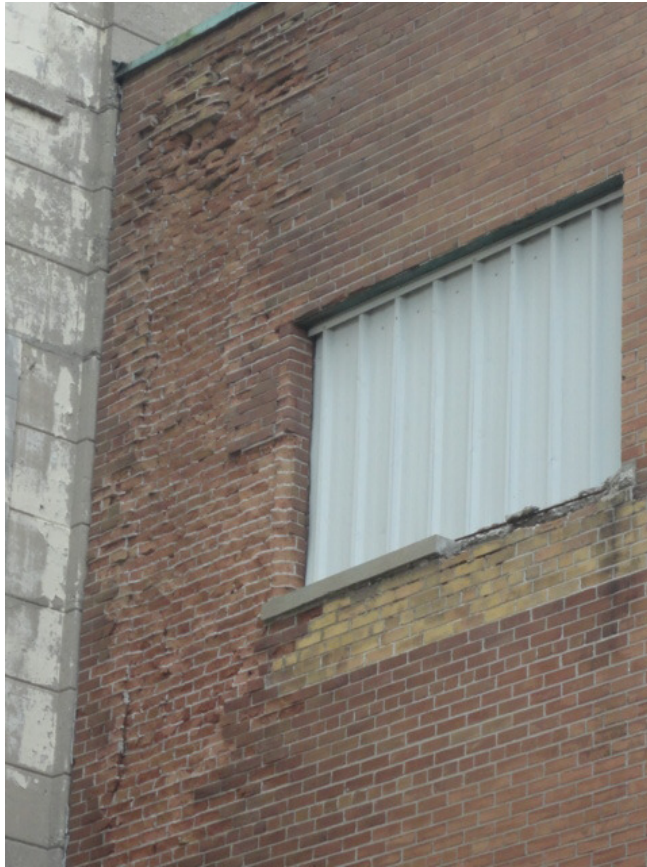
Photo #48: Deterioration of masonry wall at junction with existing wall

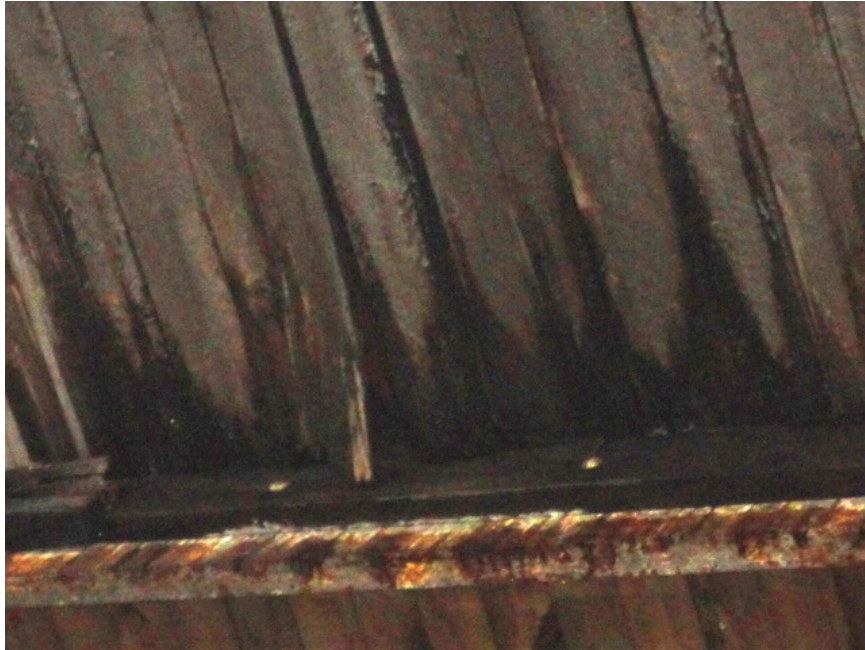
Photo #50: Typical roof deck rotting and deterioration
