November 14, 2014

**RE: Cooper Site Building**  
**350 Downie Street, Stratford, ON**  
**Roofing Components - Visual Review**

**RJC No.: TOR.103282.0008**

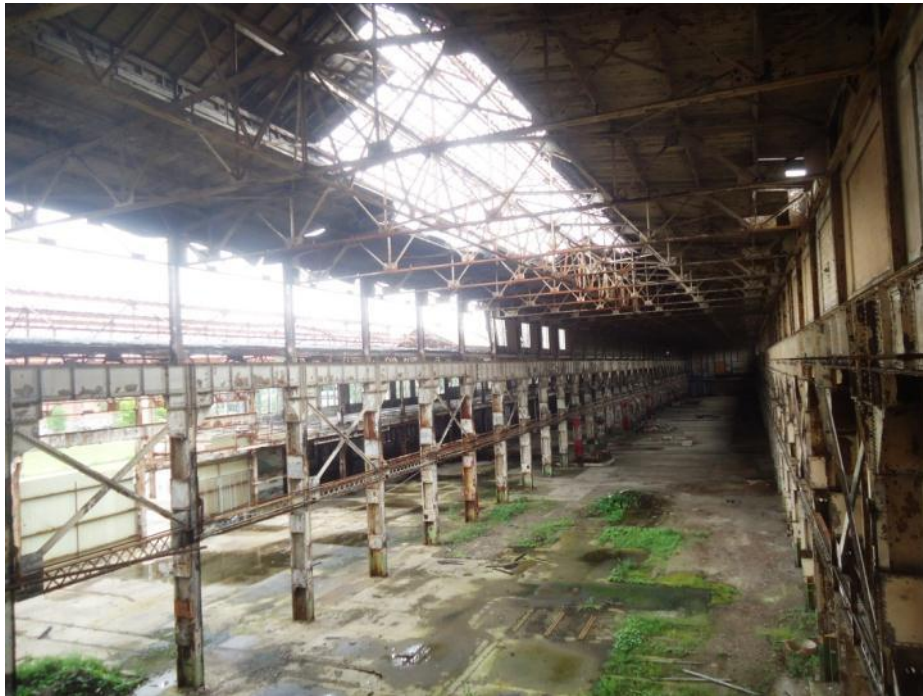
The main building located at 350 Downie Street is an abandoned industrial building constructed circa 1871 generally of riveted steel construction currently covering a footprint of approximately 160,000 square feet (*Refer to Photograph #1 in Appendix A*). The building has undergone various iterations of additions and demolition over its history prior to and following abandonment in 1989.

Photo #1: General Overview of the Structure

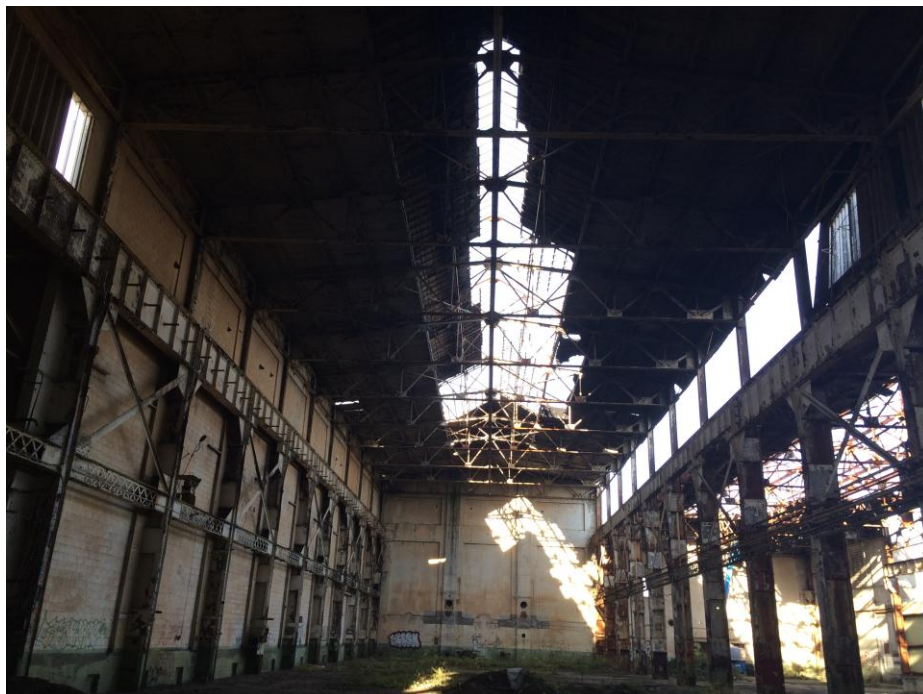
In general, the main building is constructed similarly for each of its three bays, with a higher, sloped roof with a central peak at the central half of each bay (herein referred to as the "apex") elevated by short walls from the low sloped roof on either side. The apex roof areas are generally constructed of sheet metal supported by wood strapping and metal U-channel grid. The walls at the edges of the apexes were generally constructed with wood studs sheathed with plywood, and in some cases cement board, and coated with asphalt felt, similar to the low-slope roof areas below. The assembly of the low-slope roof areas at the outer bands of each bay was typically constructed with mopped multi-ply asphalt roof membrane on solid 2" thick tongue-and-groove wooden roof deck spanning over the steel purlins (*Refer to Photograph #2 in Appendix A*).

Photo #2: General Overview of the Roof

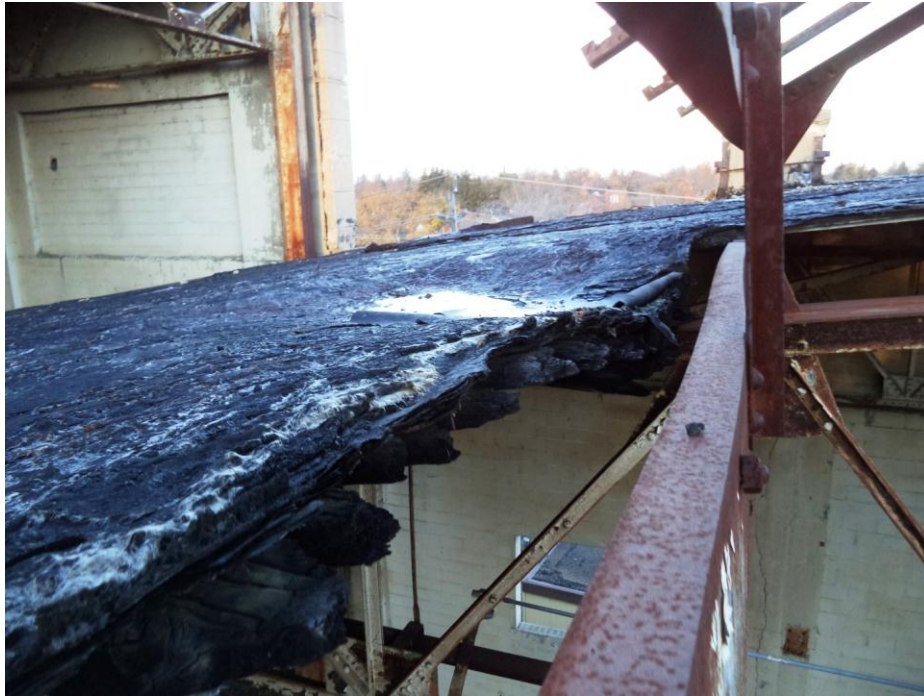
Photo #5: Typical Roof Deterioration

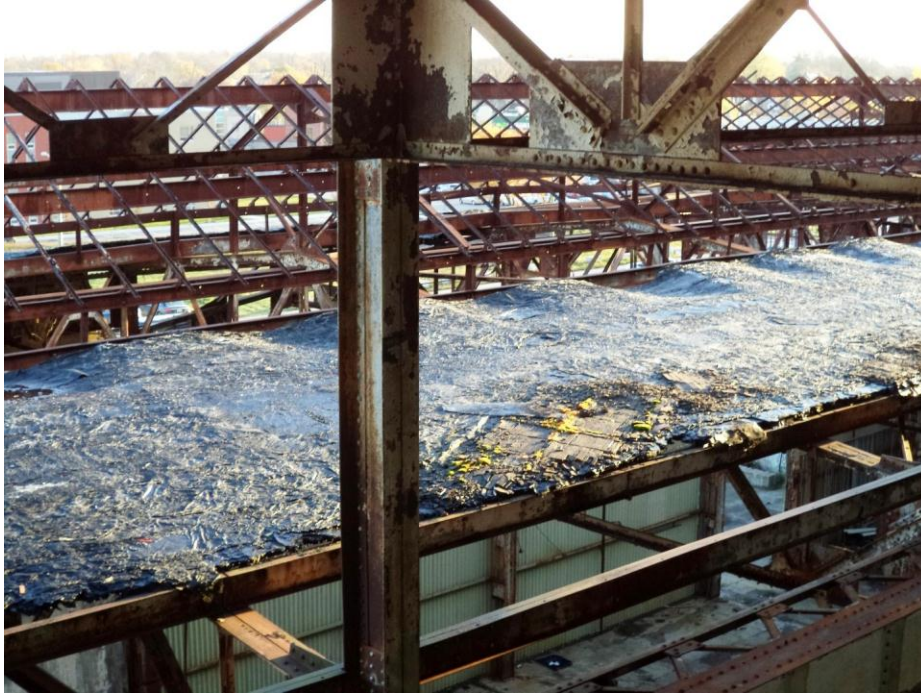
Photo #7: Typical Roof Deterioration
