May 21, 2015

RE: Cooper Site Building - 350 Downie Street, Stratford, ON
Roofing Components Visual Review
Including Hazardous Materials Abatement Costs

RJC No.: TOR.103282.0012

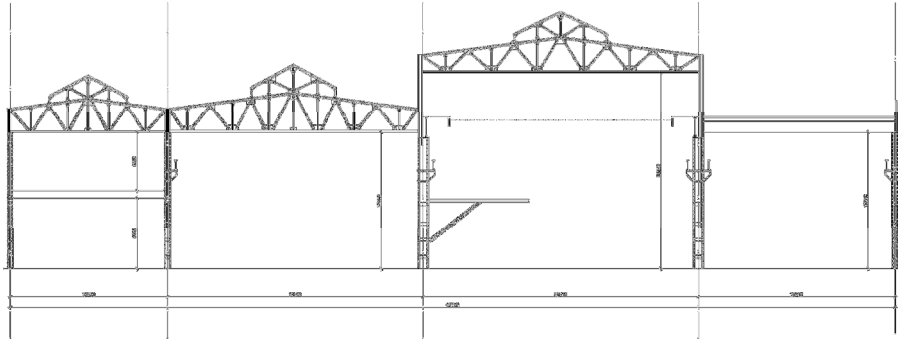
FIGURE #1: TYPICAL BUILDING SECTION

Conestoga-Rovers & Associates (CRA) collected six (6) roof deck material samples from site for hazardous material testing. Due to snow accumulation on the roof and on the ground at the building site, direct access to the roof could not be provided. Roof deck samples were collected from piles of fallen roofing material located on the ground floor slab. Based on the locations of openings through the roof deck above, the roof decking materials were assumed to have fallen directly from these locations. As a result of the limited site access, roof decking samples were collected from the two middle building bays only (*Refer to Figure #1*). Descriptions of the sample locations are as follows:

The paint on the underside of the roof deck was observed to be in fair condition and contained between 1.1% and 3.2% lead. Roofing tar and felt sample 551501533-0004 from the high roof was confirmed to contain 24.6% chrysotile asbestos. However, asbestos was not detected in samples 0001 and 0005. Please refer to Appendix A for full copies of the hazardous material test results.

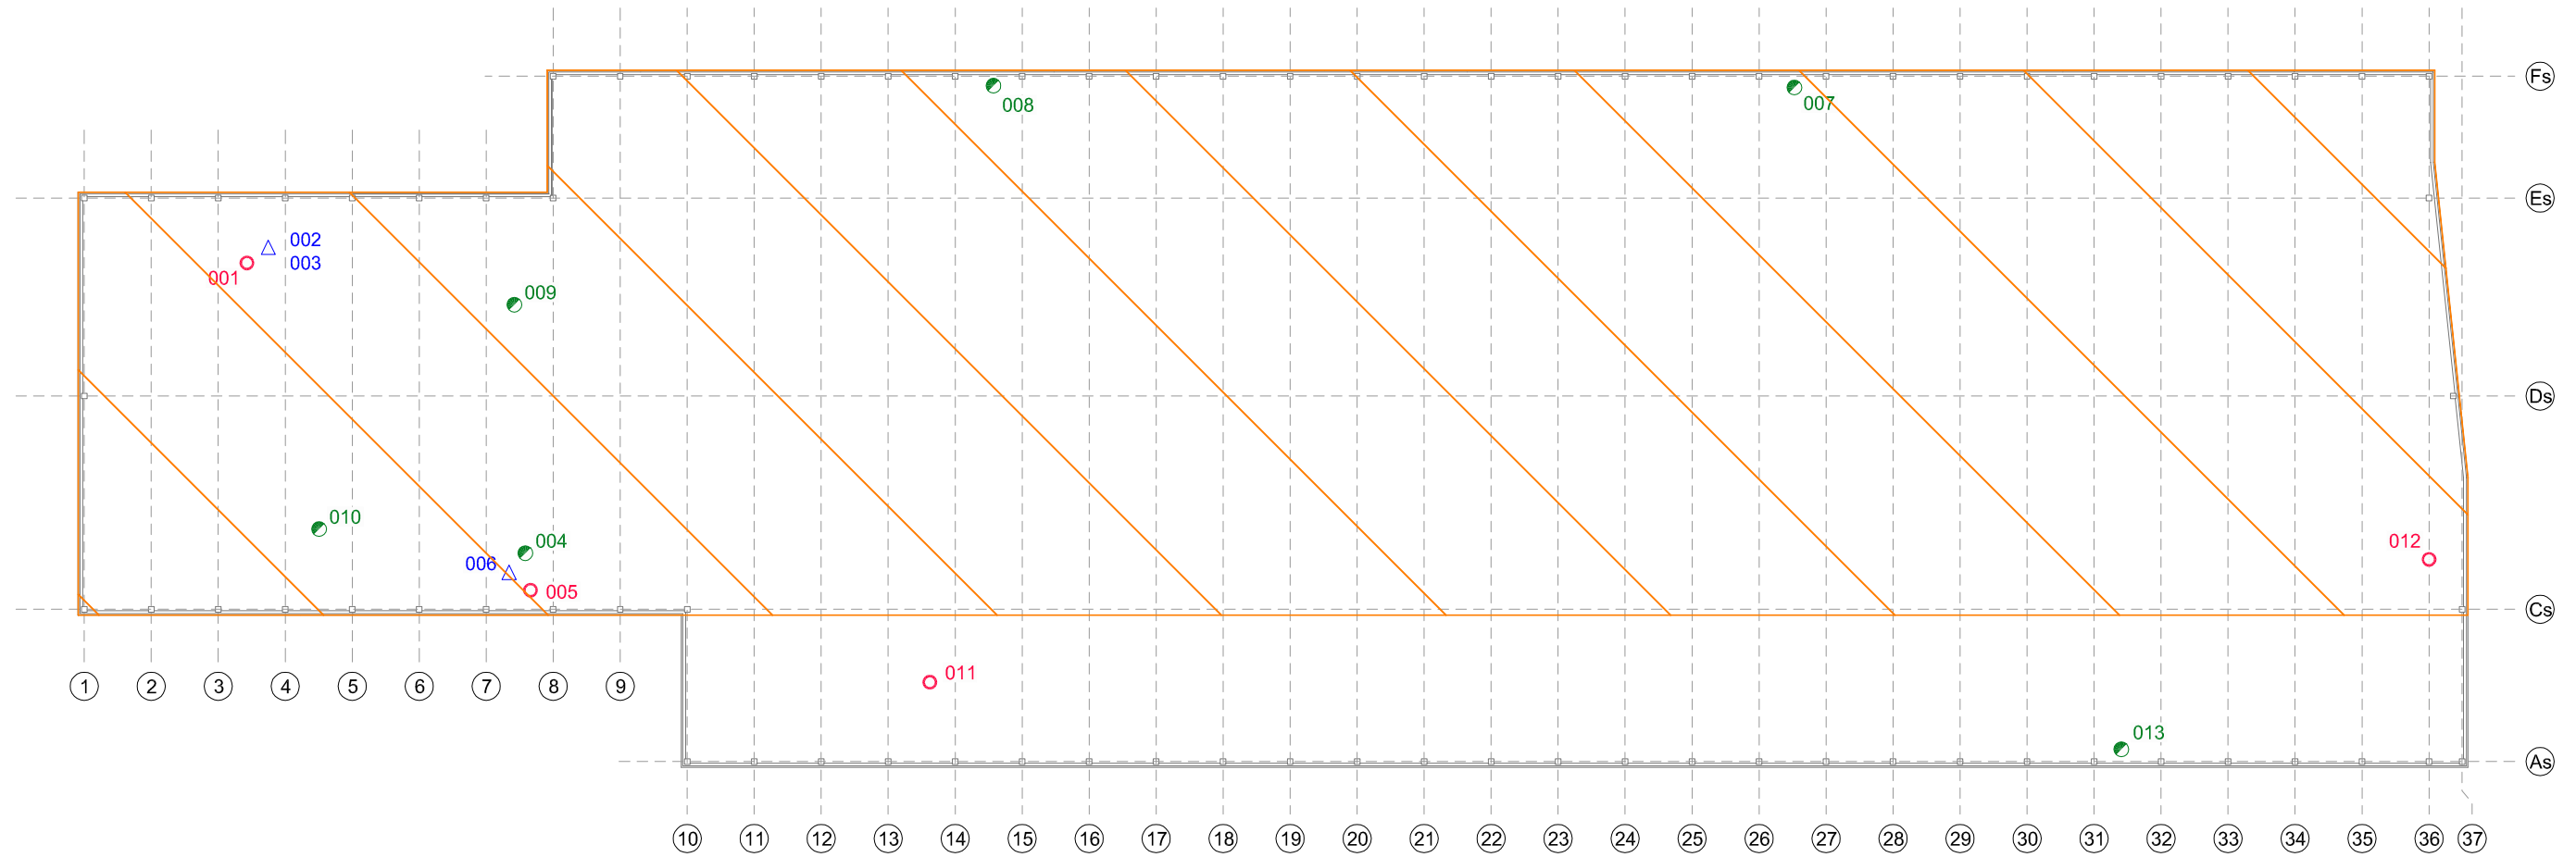
The detailed description of materials surveyed, including location, type, approximate quantity, and condition, as well as samples collected and the analytical data are provided in Table 1. The sample locations, and locations of confirmed asbestos in the roofing material are shown on Figure 1. The analytical laboratory reports are provided in Appendix A.

- Appropriate notification of the presence and hazards of asbestos should be provided to employees and contractors working in areas with ACM that may be disturbed.
- Asbestos is present in roofing materials and window caulking/glazing at the Site. If potential ACM is discovered behind walls, above ceilings, under floors or in other debris during renovation/demolition activities, work should cease until samples are analyzed. Alternatively, suspect materials can be treated as ACM for management and disposal purposes.
- An Asbestos Management Plan (AMP) should be prepared to manage ACM to prevent exposure of occupants, maintenance personnel, or renovation/demolition contractors until all ACM is removed from the Site by a qualified asbestos abatement contractor.
