**RE: Cooper Site Building - 350 Downie Street, Stratford, ON**  
**Costing for Cooper Site Partial Demolition Options**

**RJC No.: TOR.103282.0013**

## **1.0 Introduction**

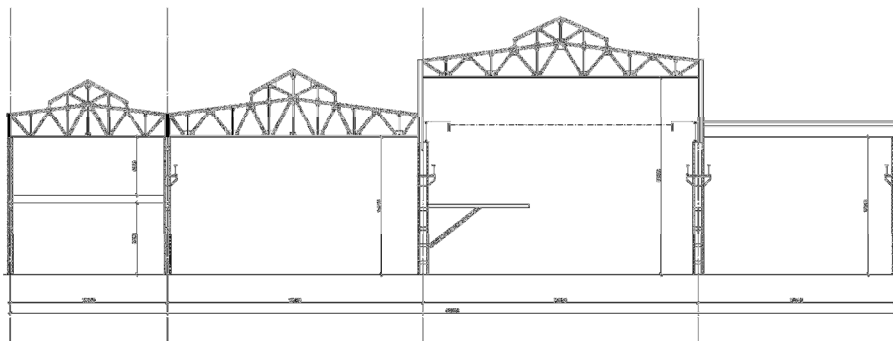
**FIGURE #1: TYPICAL BUILDING SECTION**

The remaining building is generally arranged with four (4) bays, all of which are open from the ground to the roof structure with the exception of the north-most bay, which includes a mezzanine level (*refer to Figure #1 below*). From north to south, the north-most bay (herein referred to as the "mezzanine bay") is approximately 615-ft long by 40-ft wide and 50-ft high to its peak. The next bay south (herein referred to as the "low bay") is approximately 770-ft long by 65-ft wide at a similar height of 50-ft to its peak. The 3rd bay south (herein referred to as the "high bay") is approximately 780-ft long by 70-ft wide and 67-ft high to its peak. Finally, the south-most bay (herein referred to as the "addition bay") is approximately 580-ft long by 50-ft wide and 38-ft high to the roof surface.

The building structure utilizes traditional structural steel construction with cast-in-place concrete foundations and footings. Currently, the exterior walls are typically a concrete frame fastened back to the building columns with large window openings, which have since been infilled with concrete block unit masonry. The building is clad with corrugated metal siding. The current roofing system consists of mopped multi-ply asphalt roofing on solid 2" thick tongue and groove wooden roof decking on the low slope roofs. The apex roofs are typically sheet metal supported by wood strapping and metal channel grits.

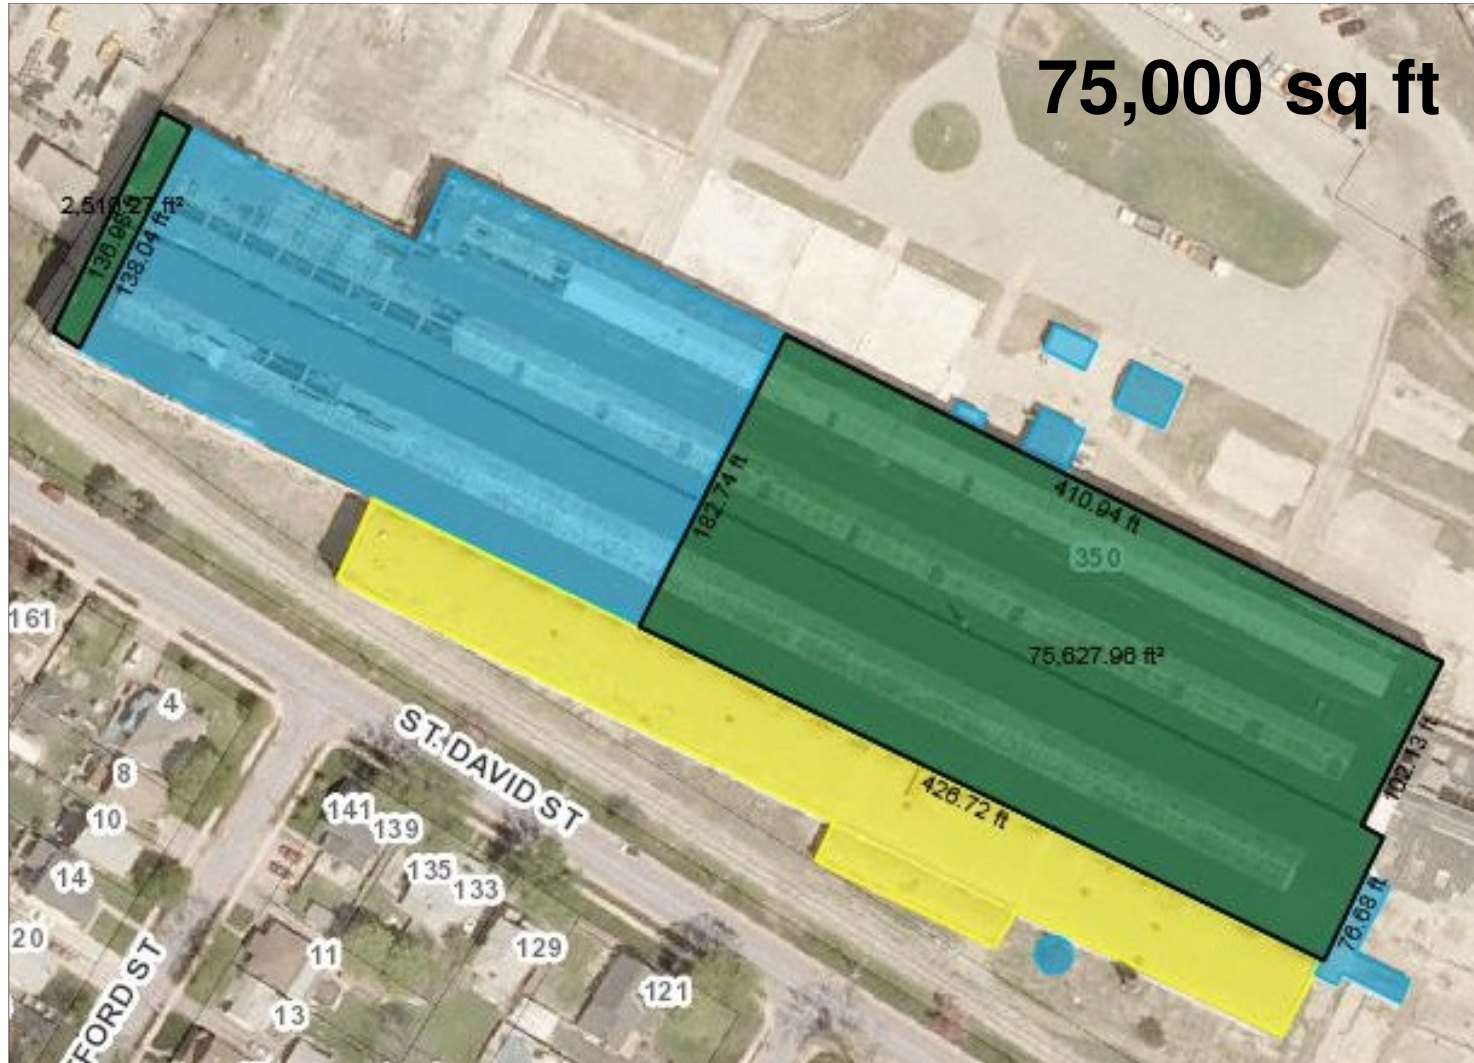
# Cooper Building – 4 May 2015

1. **Retain 75,000 Square Feet of the building ([green](#)) with west wall, steel, and date stone;**
2. Remove only loose roof material from balance of building for health and safety;
3. Because Heritage Stratford did not include the Annex ([yellow](#)) in reasons for designation, the Annex is to be demolished in the future because it has no heritage value;
4. We will contact the railway to discuss permitted uses on the site and the 30 meter setback;
5. Council will review the costing of available options and public uses as discussed at subcommittee on 30 April;
6. Commercial relator to market remaining 75,000 square feet as adaptive re-use to prospective developers until 30 September;
7. Remove cladding, loose material from building, and all outside buildings ([blue](#));
8. Fencing issue to be decided by the Chief Building Official as per the Unsafe Order.

Refer to Appendix A for Cooper Building Site Plan and documentation received from the City of Stratford . This option includes the demolition of the west half of the building up to approx. Gridline 18 (highlighted in blue). This option also includes the demolition of the west half of the south addition annex (highlighted in yellow) up to approx. Gridline 18. It includes the demolition and removal of all the roof deck materials, steel roof superstructure, mezzanine level, portion of steel columns above grade, and north and south cladding walls. In total, the building area to be demolished is approximately 70,000 sq.ft. or 44 % of the total building footprint. For structural stability of the east half of the building (highlighted in green), the
